**Tender #24147– CURTAIN WALL REPLACEMENT, MECHANICAL AND FINISH  
UPGRADES TO E.L. CROSSLEY SECONDARY SCHOOL**

# *Asbestos Assessment*

*within  
E.L. Crossley Secondary School  
350 Highway 20  
Fonthill, Ontario  
LOS 1E0*

*Dated : December 5, 2006*

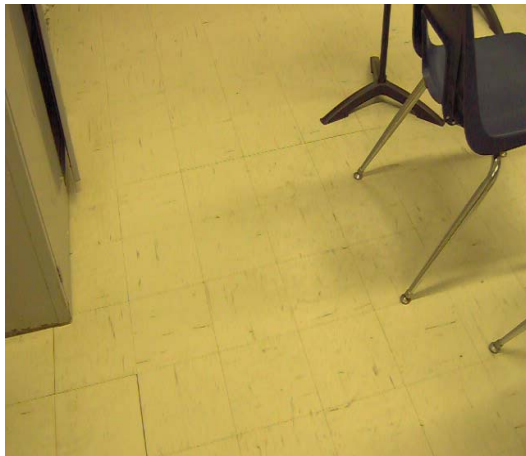
##### Floor Tile – 9" x 9" beige with brown streak:

This floor tile was sampled and identified in the basement Art Room (63-B005). The floor tile is a non-friable product that is found in numerous rooms throughout the school. This floor material is generally in good condition, however some rooms portray damage.

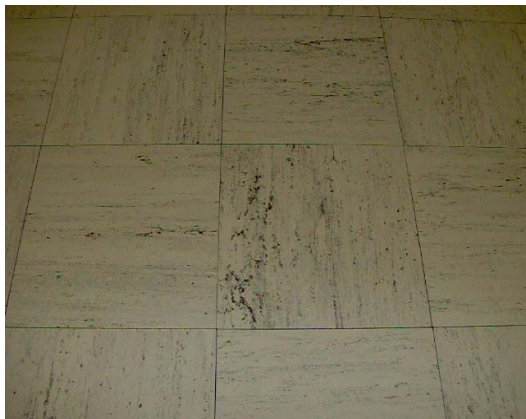
##### Floor Tile – 9" x 9" beige with green and black streak

This floor tile was sampled in the Photocopier / Supply Room on the first floor (63-1015). The floor tile is non-friable and is in found throughout the school in good condition.

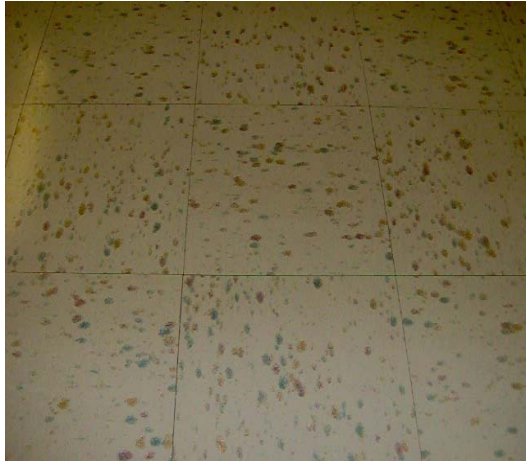
**Floor Tile – 9" x 9" beige with yellow, green and pink sparkled speck**

This floor tile was identified and sampled in the Staff Women's Common Area on the first floor (63-1020). This floor tile is a non-friable product that is in good condition and only observed in this room.

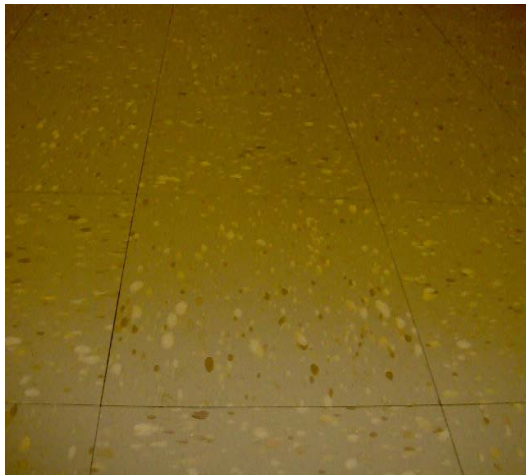
**Floor Tile – 9" x 9" grey with white and brown sparkled speck**

This floor tile was identified and sampled in the Staff Men's Common Area on the first floor (63-1023). This floor tile is a non-friable product that is in good condition and only observed to be in this room.

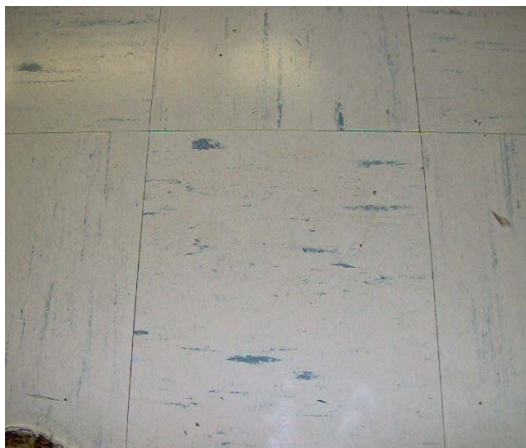
**Floor Tile – 9" x 9" beige**

This floor tile was identified and sampled in the Art Room on the first floor (63-1078). This floor tile is a non-friable product that is in good condition and found throughout the school in numerous rooms.

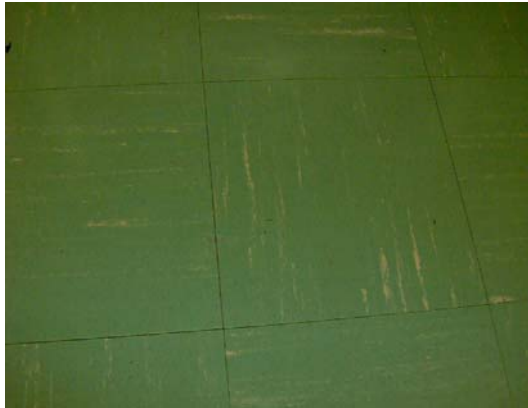
##### Floor Tile – 9" x 9" turquoise

This floor tile was identified and sampled in the Art Room on the first floor (63-1078). This floor tile is a non-friable product that is in good condition and only observed in this room.

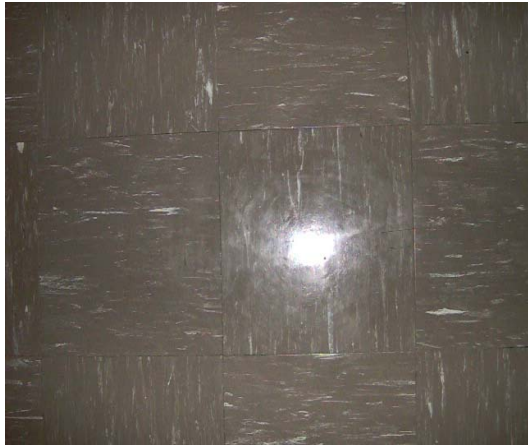
##### Floor Tile – 12" x 12" mushroom coloured

This floor tile was identified and sampled in Classroom 306 on the third floor (63-3013). This floor tile is a non-friable product that is in good condition and only observed in this room.

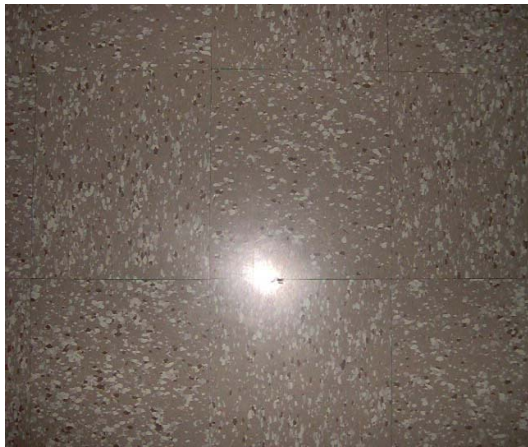
##### Floor Tile – 9" x 9" mocha with brown and white splotches

This floor tile was identified and sampled in Classroom 305 on the third floor (63-3012). This floor tile is a non-friable product that is in good condition and only observed in this room.

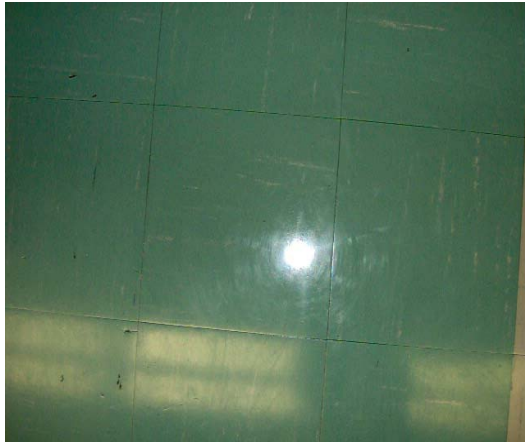
##### Floor Tile – 9" x 9" mint green with white

This floor tiles was identified and sampled in Classroom 306 on the third floor (63-3013). This floor tile is a non-friable product that is in good condition and observed to be in a few rooms throughout the school.

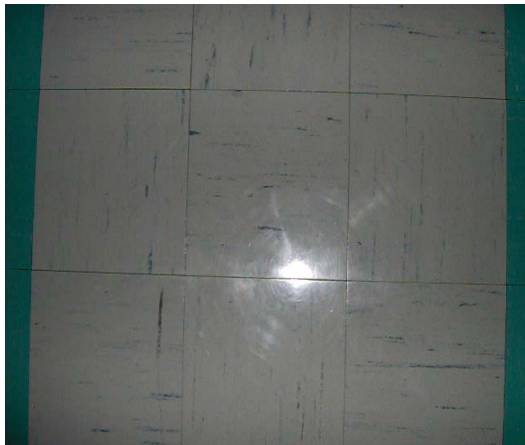
##### Floor Tile – 9" x 9" beige with blue streak

This floor tiles was identified and sampled in Classroom 306 on the third floor (63-3013). This floor tile is a non-friable product that is in good condition and observed to be in a few rooms throughout the school.

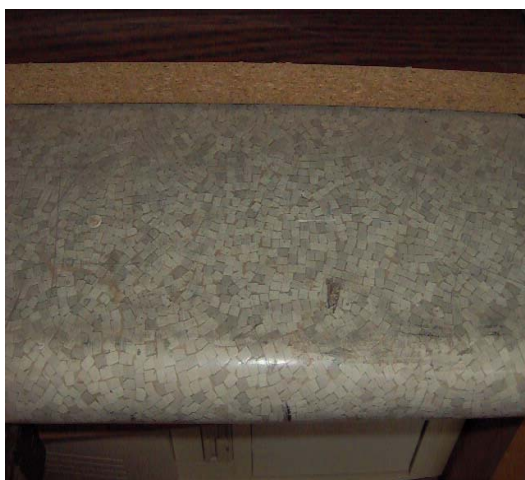
##### Linoleum – brown cobblestone pattern

This linoleum material was identified and sampled in the Wood Shop on the first floor (63-1075). This linoleum material is a non-friable product that is in good condition and observed to be in a numerous rooms throughout the school. This product is utilized as a countertop covering.

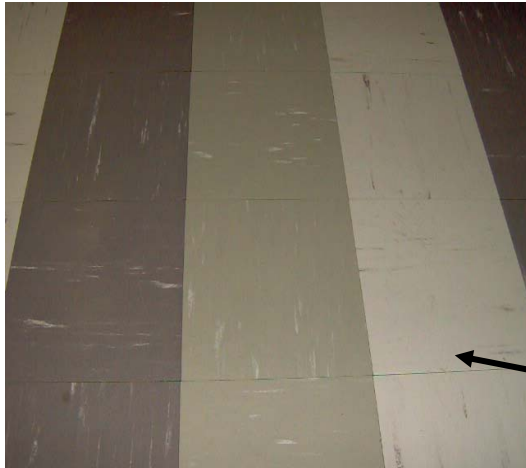
##### Floor Tile – 9" x 9" white

This floor tile was identified and sampled in the Technology Room on the first floor (68-1006). This floor tile is a non-friable product that is in good condition and found in throughout rooms in the school.

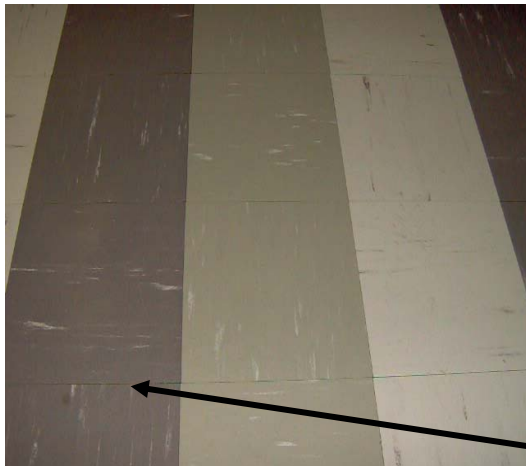
##### Floor Tile – 9" x 9" maroon

This floor tile was identified and sampled in the Technology Room on the first floor (68-1006). This floor tile is a non-friable product that is in good condition and only observed to be in this room.

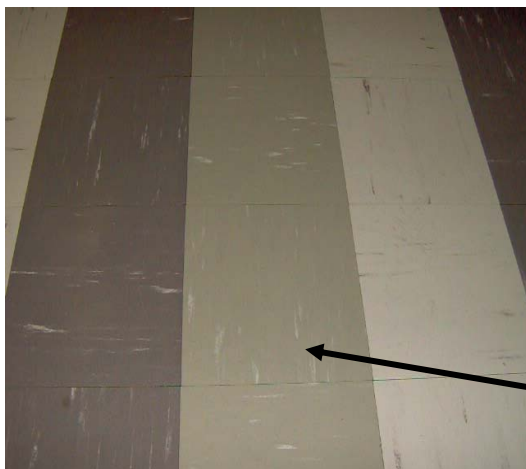
##### Floor Tile – 9" x 9" tan

This floor tile was identified and sampled in the Technology Room on the first floor (68-1006). This floor tile is a non-friable product that is in good condition and found throughout many rooms in the school.

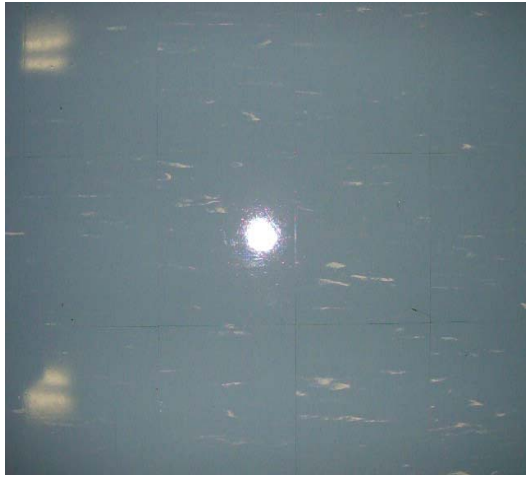
##### Floor Tile – 9" x 9" blue with white speck

This floor tile was identified and sampled in the Physic's Classroom on the first floor (68-1009). This floor tile is a non-friable product that is in good condition and found in throughout rooms in the school.

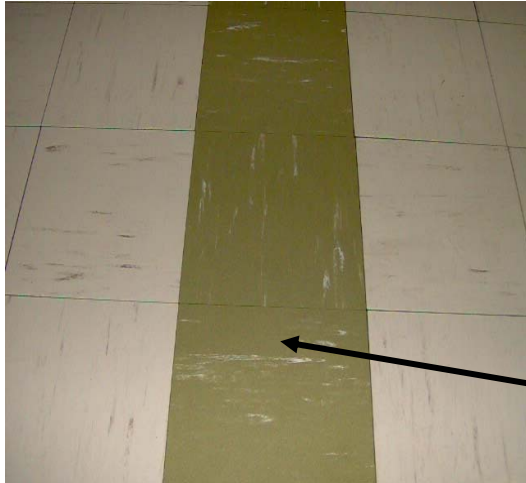
##### Floor Tile – 9" x 9" green with white speck

This floor tile was identified and sampled in the Computer Room 212 on the second floor (68-2005). This floor tile is a non-friable product that is in good condition and found throughout many rooms in the school.

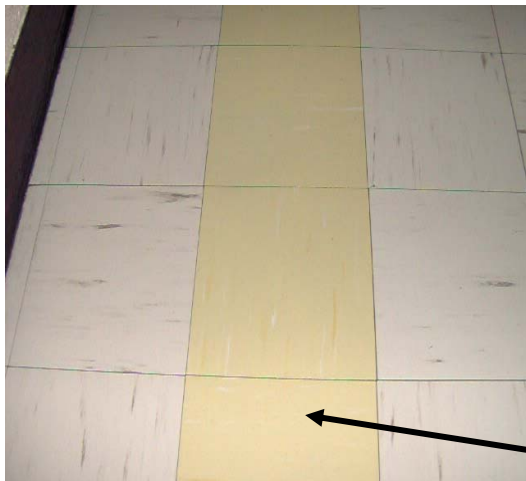
##### Floor Tile – 9" x 9" yellow

This floor tile was identified and sampled in the Computer Room 211 on the second floor (68-2011). This floor tile is a non-friable product that is in good condition and observed only in this room.

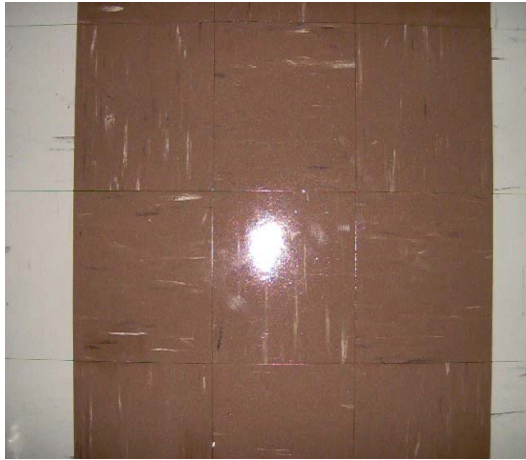
##### Floor Tile – 9" x 9" brown with white streak

This floor tile was identified and sampled in Room A3-2 on the third floor (68-3020). This floor tile is a non-friable product that is in good condition and is observed only in this room.

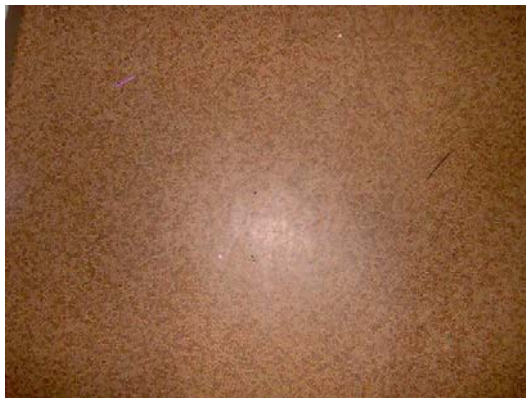
##### Linoleum – pink cobblestone pattern

This linoleum was identified and sampled in the TV/ Book Storage Room on the first floor (68-1012). This linoleum is a non-friable product that is in good condition and is observed only in this room.

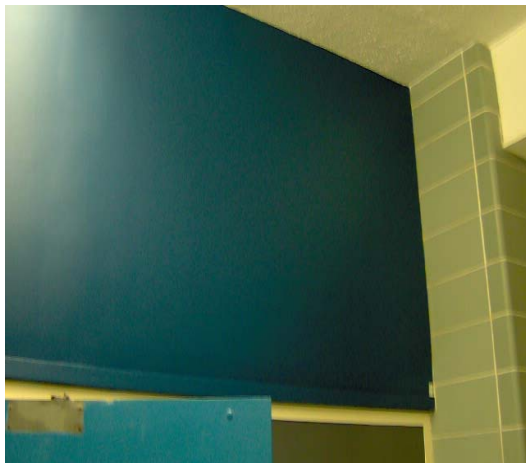
##### Drywall – joint compound

This drywall partition located above the doors was sampled in the basement Stairwell (63-B006). This drywall material is a friable product in good condition and is located in numerous areas throughout the school.

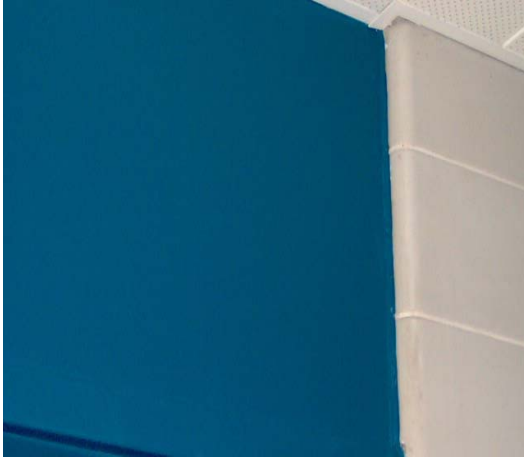
##### Drywall and Caulking

This drywall partition located above the doors was sampled on the first floor Corridor (68-1002). This drywall and caulking material are friable products in good condition and are located in numerous areas throughout the school.

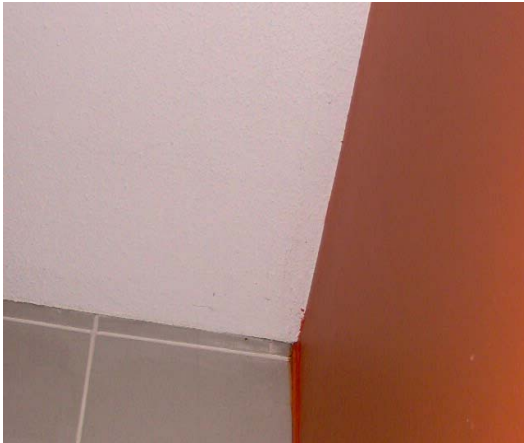
##### Plaster – stippled pattern

This plaster stippled finished material was sampled and identified in the Lecture Hall on the first floor (63-1096) as ceiling material. This material is a friable product in good condition and is located in a few rooms throughout the school.

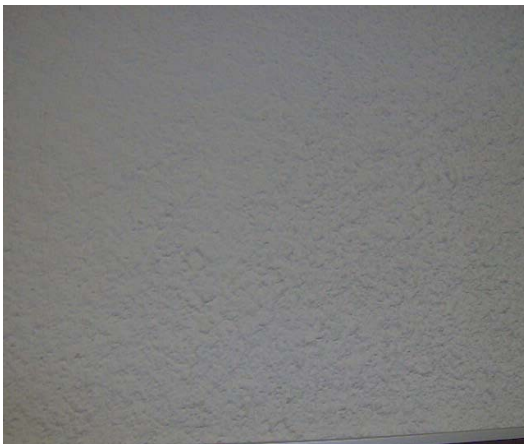
##### Plaster – popcorn pattern

This plaster popcorn finished material was sampled and identified in the Library on the first floor (63-1097) as ceiling and wall material. This material is a friable product in good condition and is located only in this area.

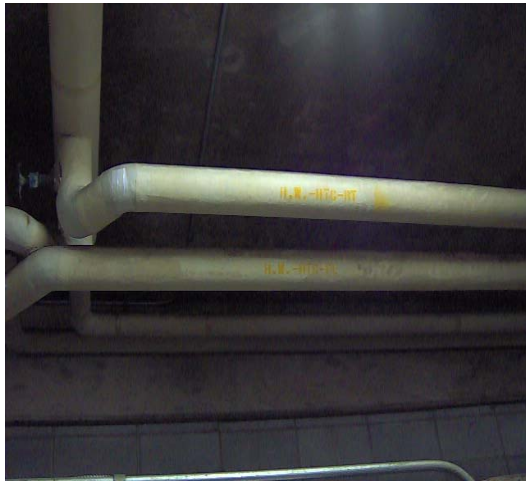
##### Insulated Cement Fitting

This material was sampled in the Air Handling Room (63-MR-004) in the basement of the school. The insulated cement on the hot water heating fitting is a grey hard cement product that is considered friable. These fittings are located within numerous rooms throughout the school, ranging from good to poor conditions.

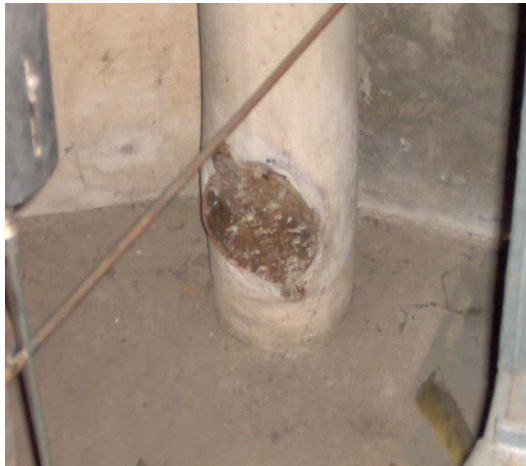
##### Insulated Cement Fitting

This material was sampled in the Air Handling Room (63-MR-004) in the basement of the school. The insulated cement on the rainwater leader fitting and view port is a grey hard cement product that is considered friable. These fittings and view ports are located within numerous rooms throughout the school, ranging from good to poor conditions.

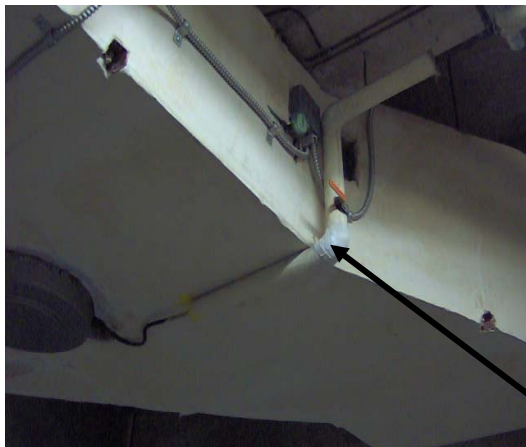
##### Insulated Cement Fitting

This material was sampled in the Air Handling Room (63-MR-004) in the basement of the school. The insulated cement on the domestic cold-water fitting is a grey hard cement product that is considered friable. These fittings are located within numerous rooms throughout the school in good condition.

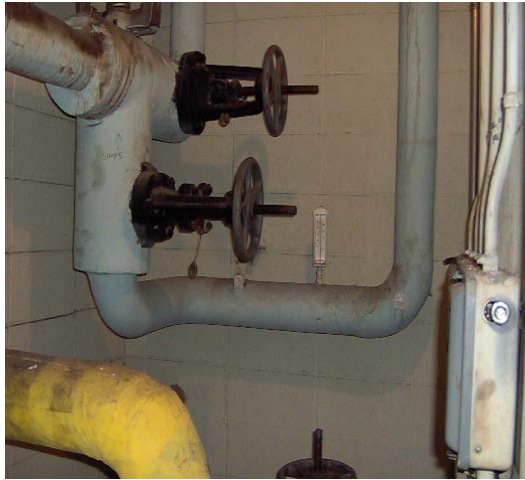
##### Insulated Cement Fitting / Valve

This material was sampled in the Custodian Room on the first floor (63-1092). The insulated cement on the hot water heating fitting and valve is a grey hard cement product that is considered friable. These fittings are located within numerous rooms throughout the school, ranging from good to poor conditions.

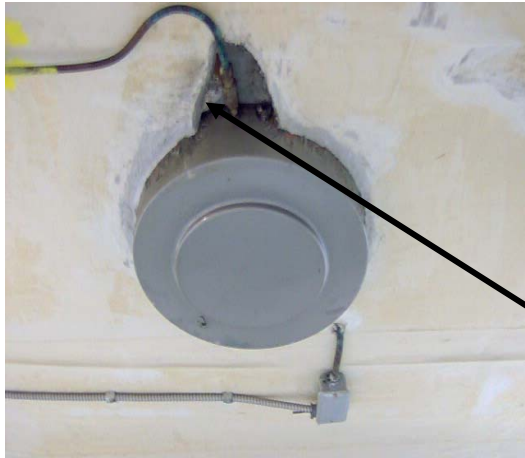
##### Insulated Cement

This material was sampled in the Air Handling Room (63-MR-004) in the basement of the school. The insulated cement packing on the HVAC system and in the seams of the insulation is considered friable. This insulated cement packing material is located throughout numerous rooms in the school and typically in good condition.

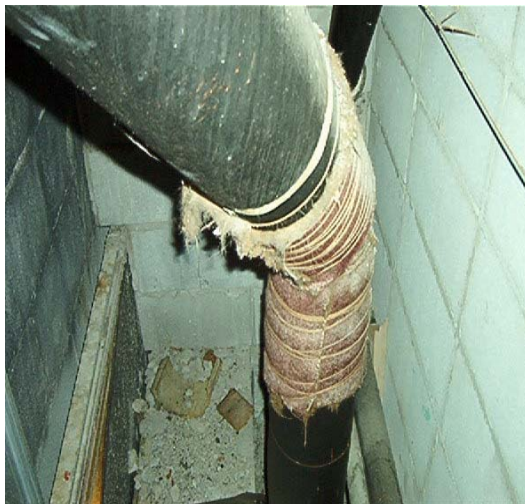
##### Cloth / Paper Insulation

This material was sampled in the Pipe Chase on the second floor from the Pipe Chase (68-2020). The cloth and paper insulation is associated with horsehair insulation on the rainwater leader fitting. The cloth and paper material are considered friable and in good condition. This type of insulation is only found within this pipe chase.

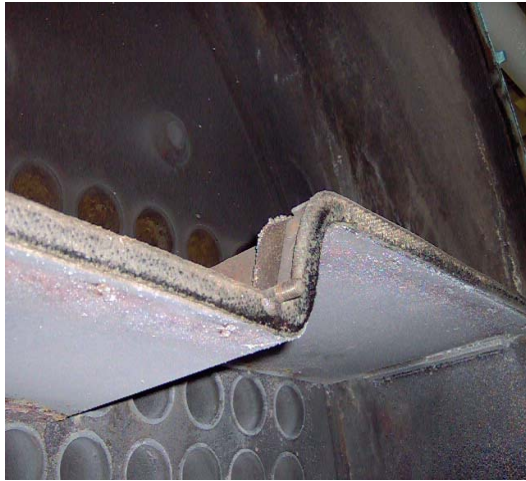
##### Cloth Gasket

This material was sampled in the basement Boiler Room (63-MR-002). This cloth gasket was identified on the cross bracket at the burner throat end of the boiler. This cloth material is considered a friable product and suspected to be in all boilers within the school.

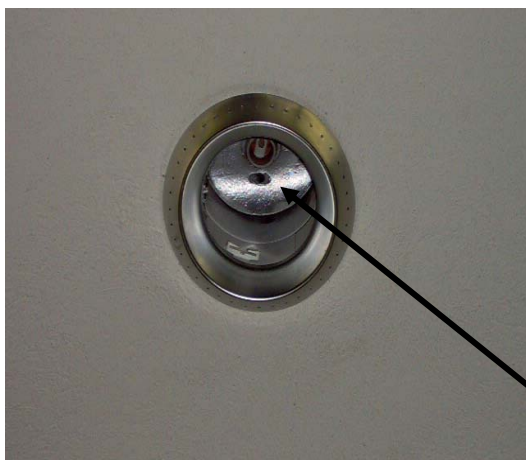
##### Foil Faced Light Gasket

This material was identified and sampled in the Girl's Coach Room on the first floor (63-1038). This material is utilized within light fixtures for fire protection and exhibits a foil face with a paper texture. This gasket is a friable product and found in numerous rooms throughout the school.

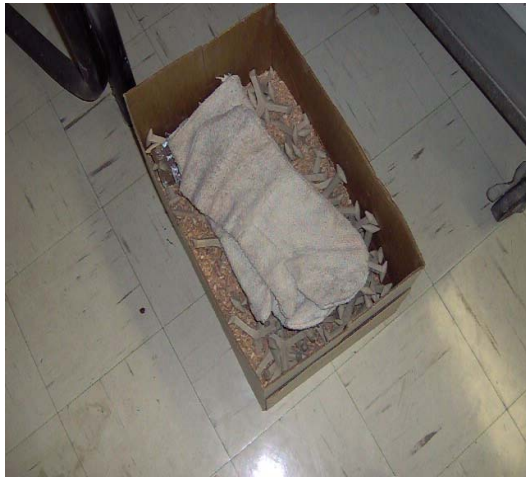
##### Cloth Mitts

These cloth mitts were identified and sampled in the Art Room on the basement floor (63-B005). These mitts are utilized for clay pottery to minimize the heat factor emitted. They have a rough feel with a cloth appearance. These mitts are considered friable and found only in this room.

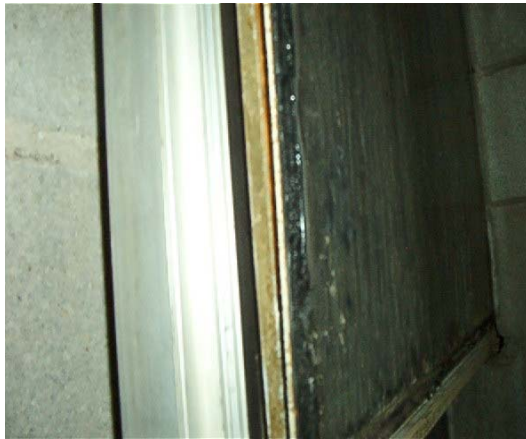
##### Cement Panel (Transite)

This transite material was identified in the Pipe Chase on the second floor (68-2020). The transite fills the wall space below all windows to the 1968 addition. Black laminate is over top of the cement board. This material is a hard, non-friable material that is in good condition. This panel

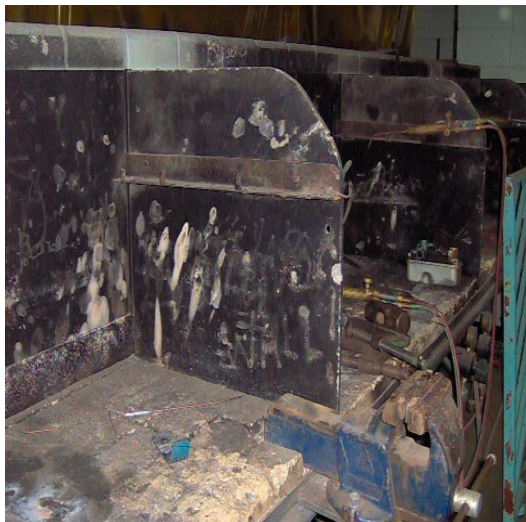
##### Transite Board

This transite material was identified and sampled in the Engine Shop Class on the first floor (68-1005). This transite board is located as partition sides for each welding station. This material is hard and has a stippled texture on one side. This material is also found in this room as the bulkhead above the stations and as a wall near the fume hood. It is a non-friable product and can be identified in other rooms in the school.

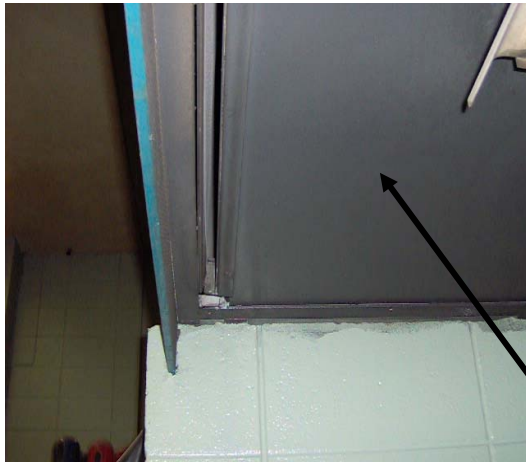
##### Millboard

This material was identified and sampled in the Engine Shop Class on the first floor (68-1005). This millboard material is located as ceiling material at each welding station. It is a soft material once punctured, classifying it as a friable product. This material was only found in this room of the school.
