**Tender #24147– CURTAIN WALL REPLACEMENT, MECHANICAL AND FINISH  
UPGRADES TO E.L. CROSSLEY SECONDARY SCHOOL**

# *Asbestos Assessment*

*within  
E.L. Crossley Secondary School  
350 Highway 20  
Fonthill, Ontario  
LOS 1E0*

*Dated : December 5, 2006*

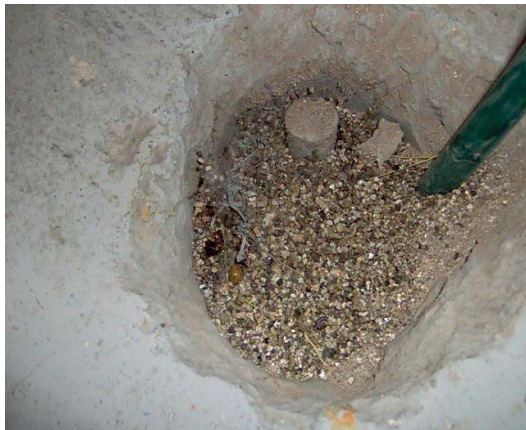
##### 1963 Section

This material is identified as containing 85% chrysotile asbestos.

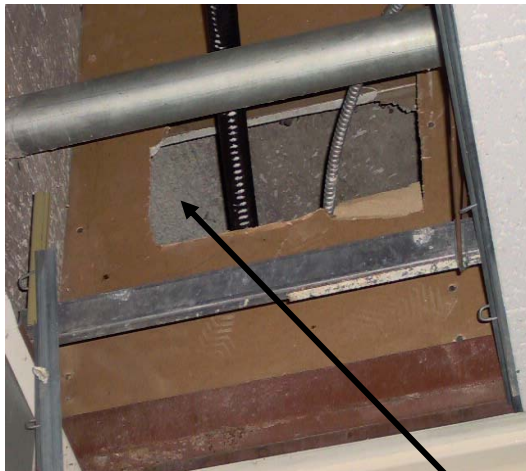
##### Fireproofing

This fireproofing material was identified and sampled in the exterior of the building under the metal pan overhang (E001). This material has a greyish white colour and exhibits a fluffy texture. Fireproofing is considered a friable product and is located in numerous areas throughout the school. If accessing above the metal pan or ceiling tiles, a type II entry is required.

This material is identified as containing 35% chrysotile asbestos.

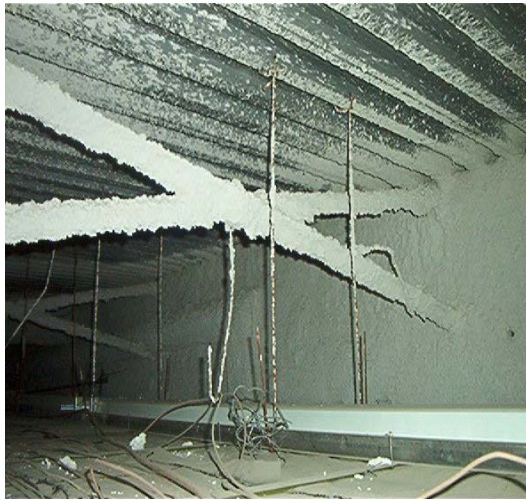
##### Fireproofing

This fireproofing material was identified and sampled in the Pipe Chase on the second floor (68-2020). This material has a greyish white colour and exhibits a fluffy texture. Fireproofing is considered a friable product and is located in numerous areas throughout the school. The fireproofing above the ceiling tends to have excessive overspray on the concrete block and the top of the ceiling tiles. If going above ceiling tiles, a type II entry is required.

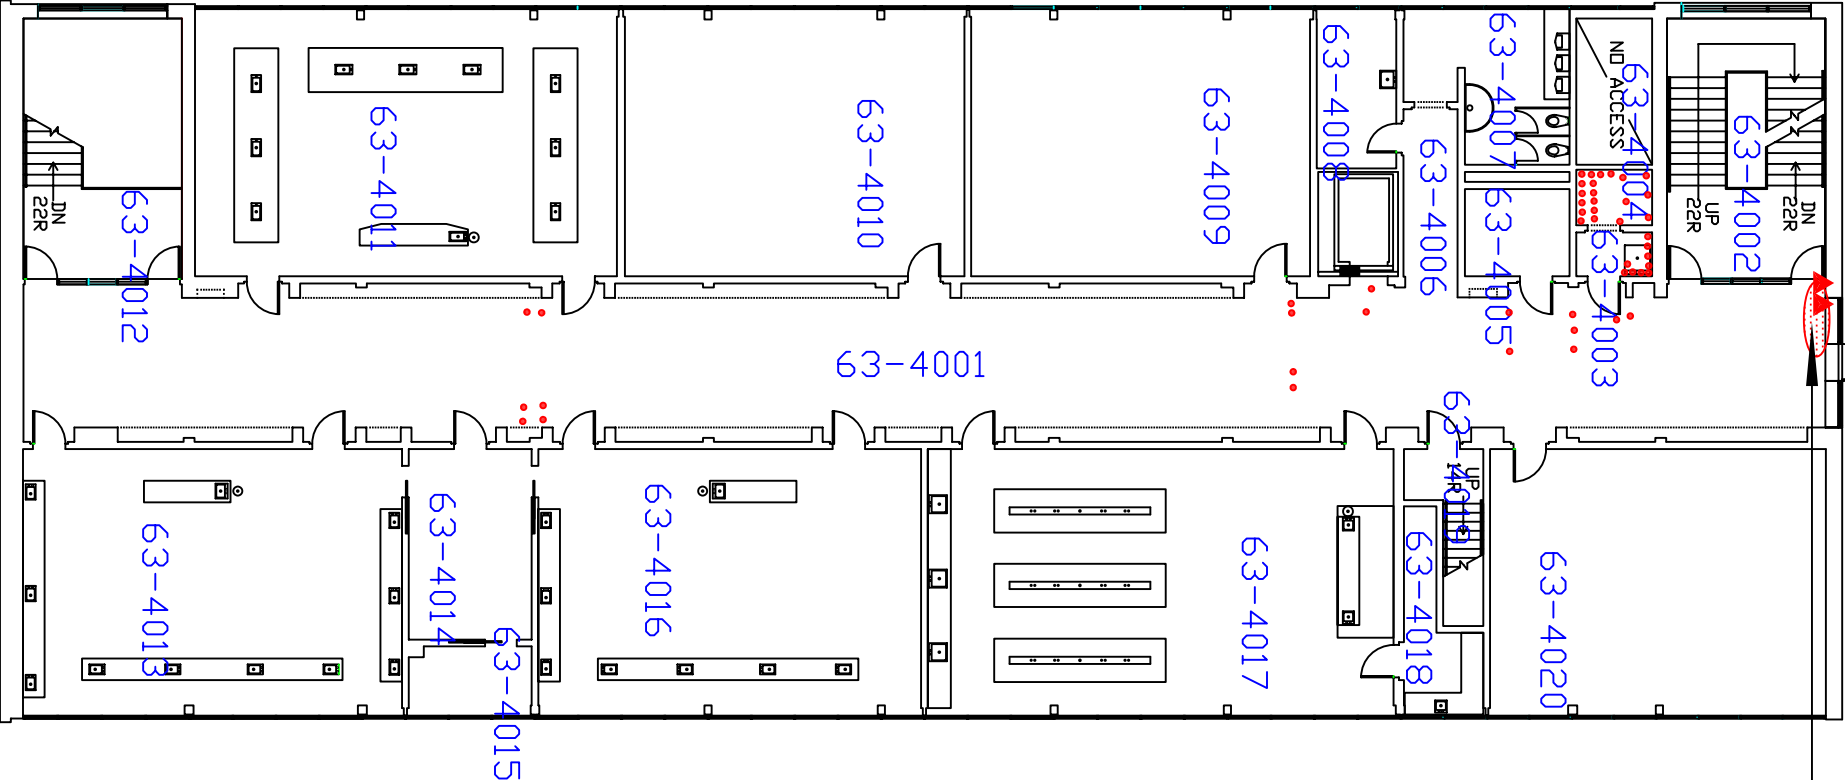
4TH FLOOR  
THERMAL MATERIALS

NOTE:  
FIRE PROOFING DO NOT  
ENTER CEILING SPACE
