THE CORPORATION OF THE CITY OF NIAGARA FALLS

ADDENDUM #1

RFT12-2021

City of Niagara Falls Municipal Service Centre Renovation

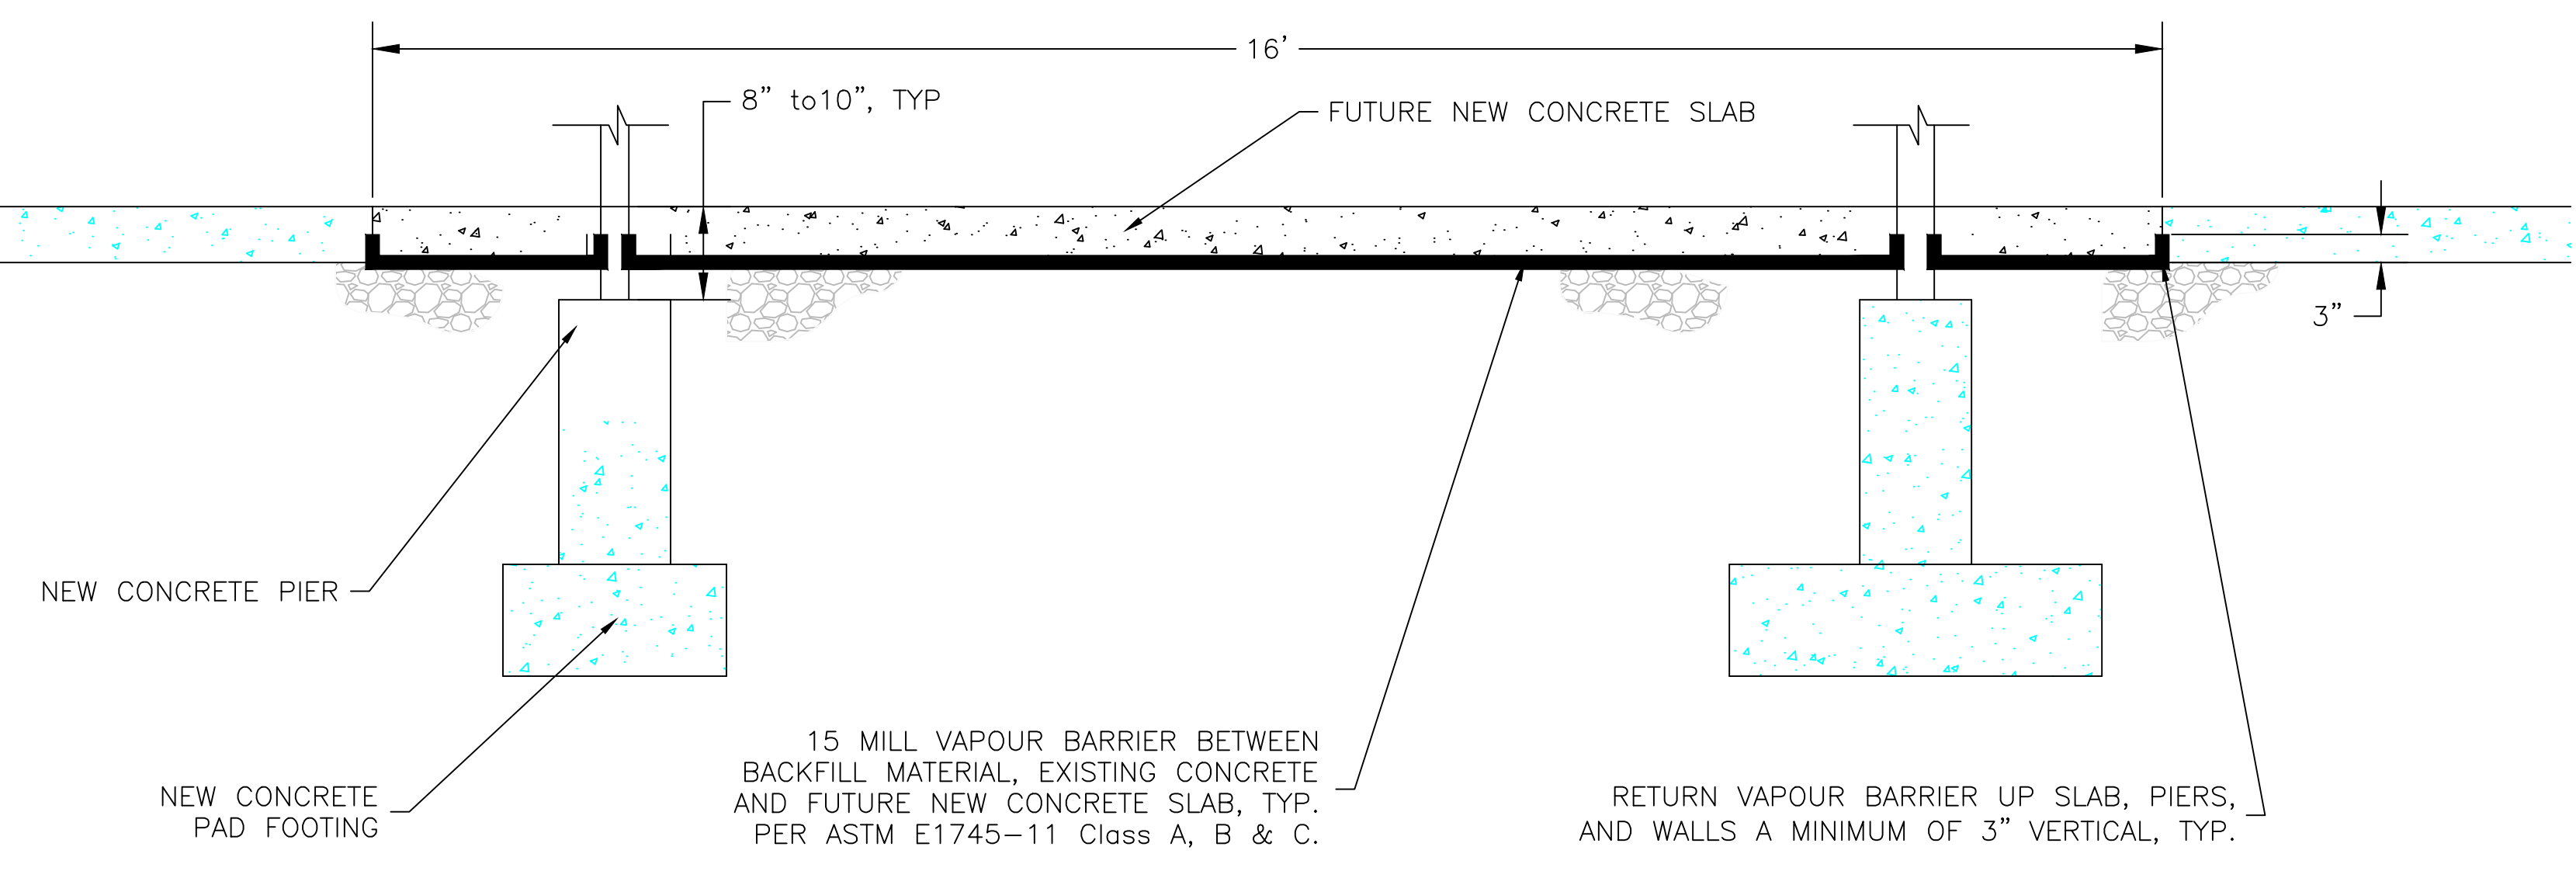
VAPOUR BARRIER LOCATION DETAIL - TYP NTS

15 MILL VAPOUR BARRIER BETWEEN BACKFILL MATERIAL, EXISTING CONCRETE AND FUTURE NEW CONCRETE SLAB, TYP. PER ASTM E1745-11 Class A, B & C.

RETURN VAPOUR BARRIER UP SLAB, PIERS, AND WALLS A MINIMUM OF 3" VERTICAL, TYP.

- SEE ACA ENGINEERING SERVICES LIMITED DRAWING # S1 "FOUNDATION PLAN / SECTIONS NOTES FOR EXACT LOCATION AND DIMENSIONS OF NEW FOOTINGS AND PIERS. THIS DRAWING IS TO SHOW THE APPROXIMATE LOCATION OF CONCRETE / ASPHALT DEMOLITION AND THE RECOMMENDED VAPOUR BARRIER ARRANGEMENT

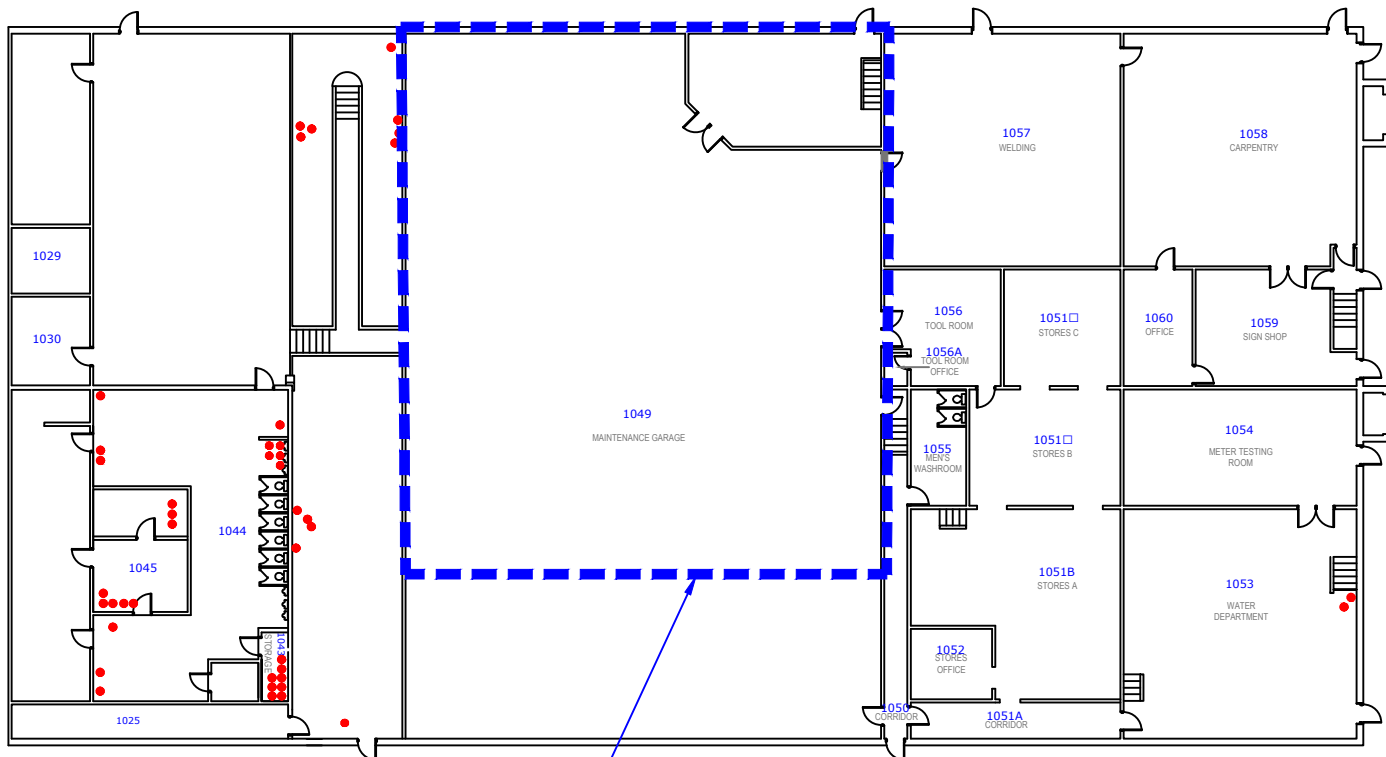
2021: THERMAL CEMENT PIPE
FITTINGS REMOVED FROM
GARAGE BAY AREA AT
CEILING HEIGHT

NOTE: (1) ASBESTOS SURVEY NOT COMPLETELY
INTRUSIVE. IN THE EVENT SUSPECT ASBESTOS
MATERIALS THAT ARE NOT IDENTIFIED IN THE
ASBESTOS SURVEY ARE DISCOVERED THROUGH
RENOVATION/DEMOLITION, CONTRACTOR TO
REQUEST VERIFICATION FROM THE OWNERS
CONSULTANT.
